Bristell B23	Doc-Nr: ADxC-73-SB-020 Issue: A Date: 09.01.2023 ChangeNr.: ADxC-73-DC-061
Service Bulletin

Bristell B23 Inspection and change of ballast attached to engine
--

ATA 72 ENGINE – ballast attached at engine

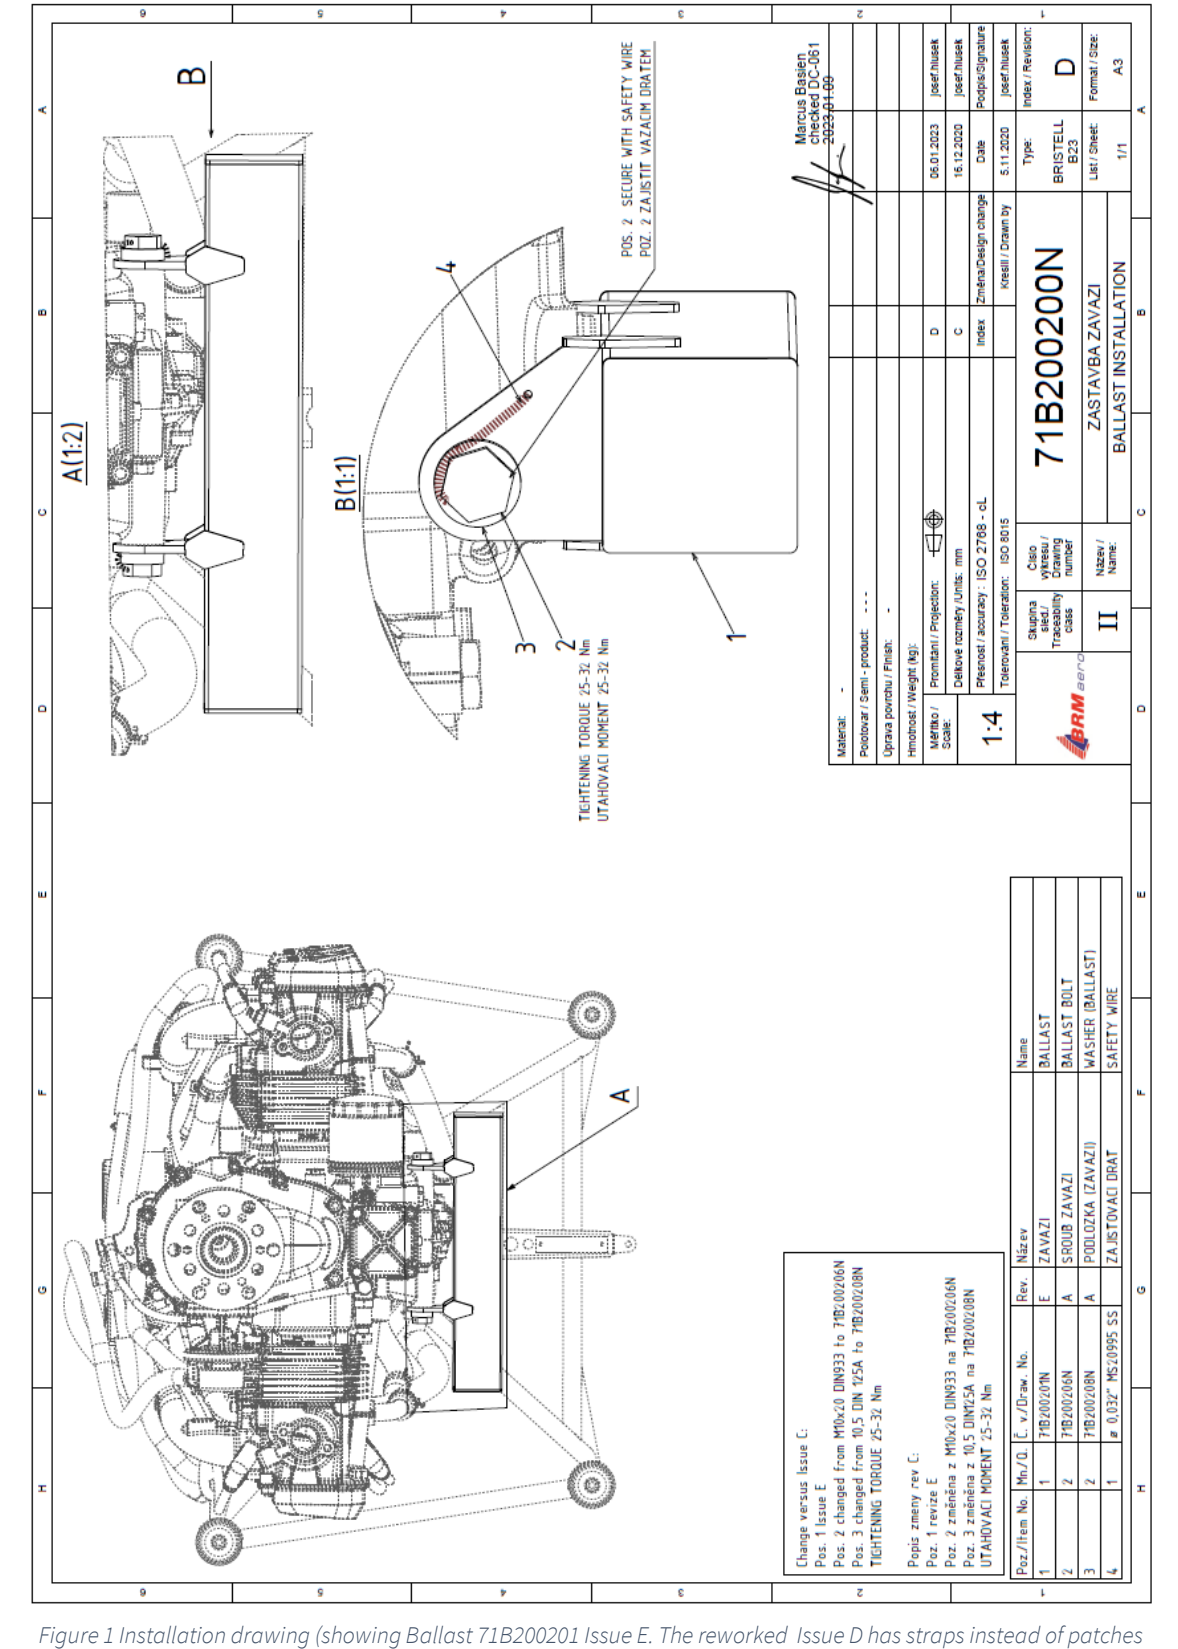
Figure 1 Installation drawing (showing Ballast 71B200201 Issue E. The reworked Issue D has straps instead of patches

- Remove engine cowling
- Remove safety wire at ballast attachment bolts
- Install factory reworked ballast PN 71B200201N issue D (*OR new 71B200201N issue E Ballast*) using bolts PN 71B200206N issue and 71B200208N issue A washer (2ea) according installation drawing 71B200200N issue D; Torque attachment bolts to 26-32 Nm
- Perform engine run up according AFM, perform minimum 5 rapid RPM changes idle to max RPM. Shut down aircraft according AFM.
- Recheck torque of bolts PN 71B200206N issue A after cool down.
- Reapply safety wire.
- Reinstall cowling.

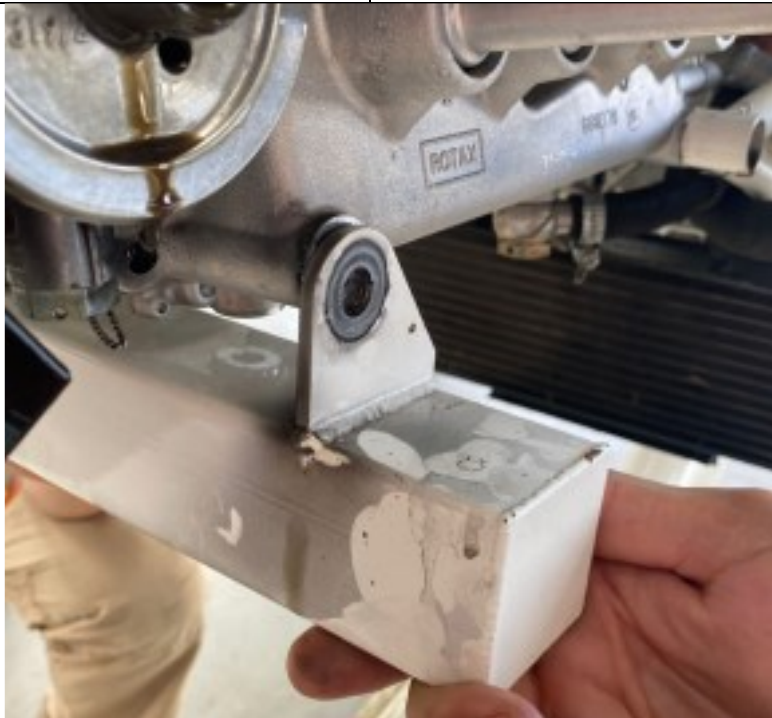
- Remove engine cowling
- Visually inspect the surface of the ballast for cracks occurrence in the area of attachment to the engine and/or signs of a loose connection indicated by the appearance of grey-black dust, see Figure 4 in Appendix.

Figure 4 Grey dust on ballast indicating wear on bolt/thread/attachment)

- Remove safety wire at ballast attachment bolts
- Remove bolts and ballast
- Discard bolts
- If grey dust was found: Visual inspect engine threaded hole: no thread damage is allowed. In case of thread damage contact BRM, installation of helicoil might be needed.
