Scratching- protection of seat bracket (DC-096)	Doc-Nr: ADxC-73-SB-033 Issue: A Date: 22.05.2023 ChangeNr.: ADxC-DC-73-096
Service Bulletin

<p>Scratching-protection of seat bracket (DC-096)</p> <p>Introduce means of protection against chafing of the solid rivets heads on the main center spar and of the spar web from the seat brackets</p>
--

0 General
0.1 ATA Code ATA 25 EQUIPMENT/FURNISHINGS – Seat assembly/installation ATA 53 FUSELAGE – Main center spar
0.2 Effectivity All BRM Aero B23 models and serial numbers, without installed DC-096. TCDS: EASA.A.642

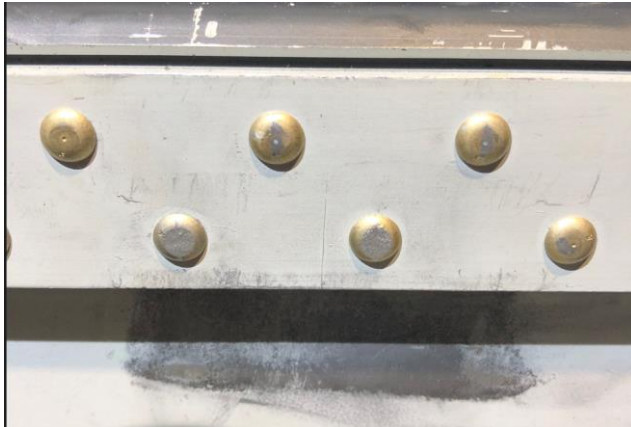
Eliminating the root cause of chafing of the solid rivets heads on the main center spar and of the spar web.

Figure 1: Observed wear on main spar rivet heads and web.

The unsafe condition is excessive wear of the solid rivets heads on the main center spar and of the spar web.

If criteria in Section 0 met, replace the seat bracket 25B210051N by seat bracket assembly 25B210052N.

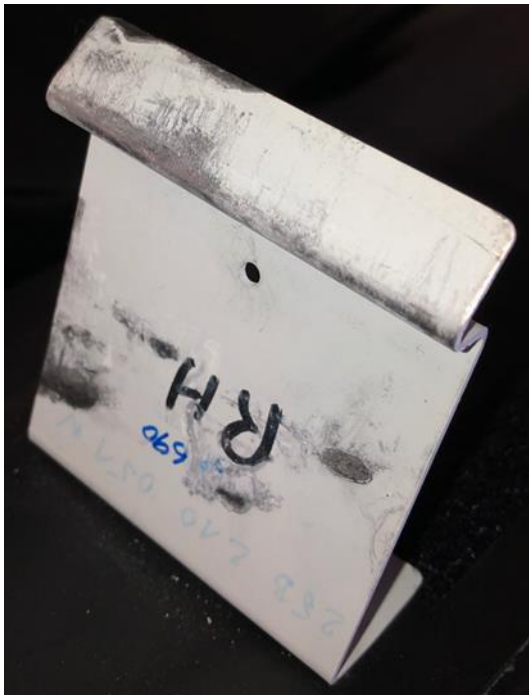
Figure 2: Observed wear on seat bracket (25B210051N, dismantled)

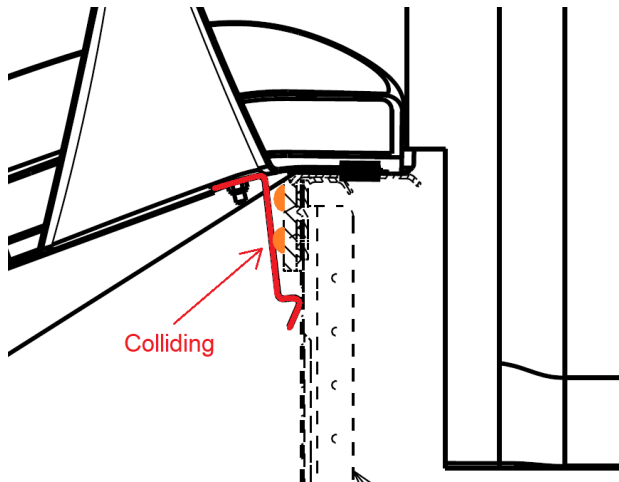
Figure 3: Installed original seat bracket (red line) on rivet heads (orange).

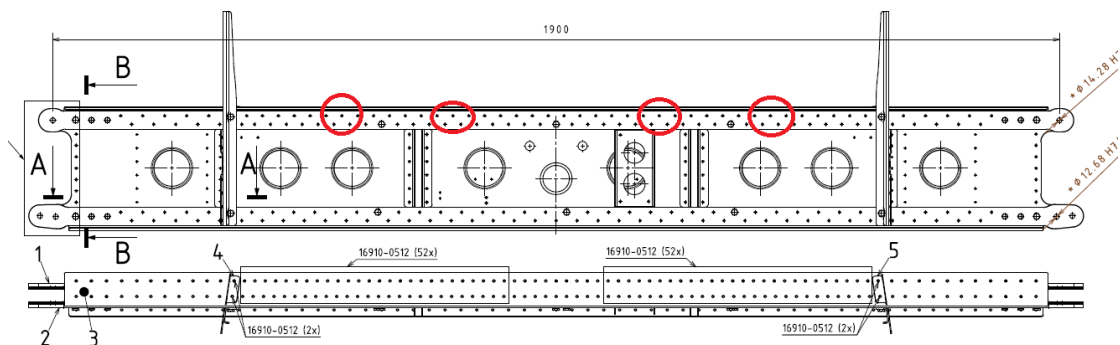
Figure 4: Affect rivets (red circles)

- b) If chafed diameter is larger:
 - i) replace original rivet by a CherryMax rivet CR3553-5-08.
 - ii) Check fastened rivets from the inside of the main spar, e.g. by means of mirror ore borescope.
 - c) Check concerned web areas for excessive wear. If it is not excessive, polish and paint them. If it is excessive, request repair order.
- 3) Make a log book entry and add note to aircraft CAW documentation that this Service bulletin has been incorporated.

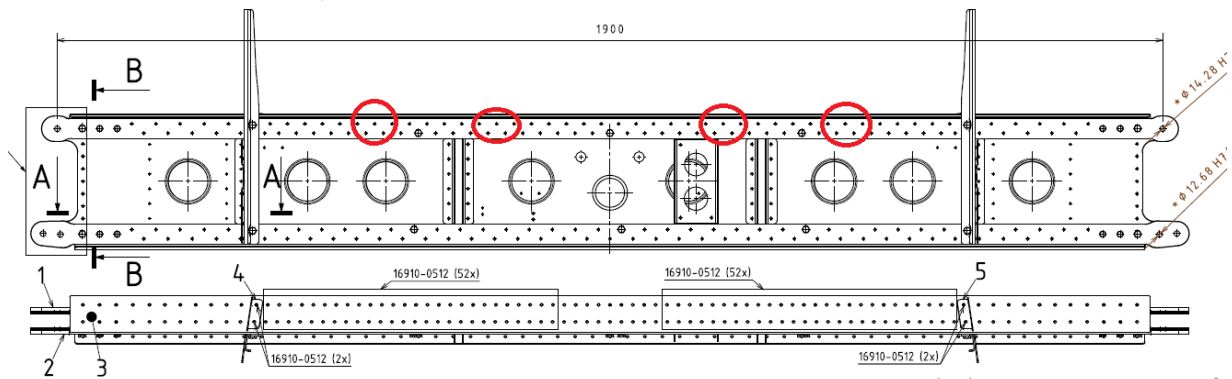
- a) Check wear of original rivets, the maximum allowed chafed diameter is 4 mm on the concerned rivet.
