Propeller mounting inspection	Doc-Nr: ADxC-73-SB-034 Issue: A Date: 31.05.2023 ChangeNr.: DC-097
Service Bulletin

Propeller mounting inspection
SERVICE BULLETIN

SB is released to inspect and remove unwanted grease at propeller mounting.

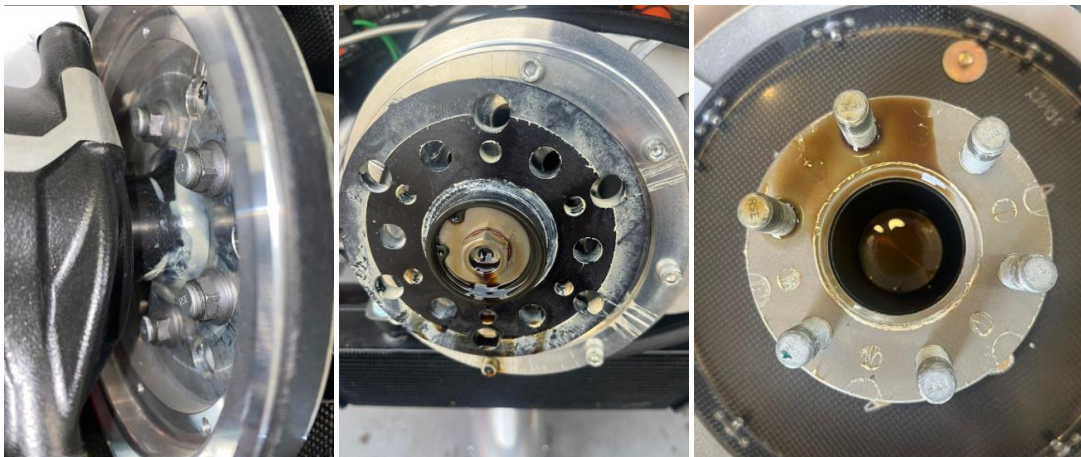
It was recognised that grease might be in the propeller mounting contrary to the propeller manufacturer installation manual. Cause is that conservation grease of new Rotax engine was not removed during installation.

This is potentially safety critical as bolts can lose pre-tension if remaining grease exits the flange. This is potentially safety critical as friction between engine and propeller flange is reduced. This process however is extremely slow.

- 1) Check If criteria from Section 0 is met.
- 2) Inspect parts for grease at the propeller-engine flange connection. If grease is found¹, follow ADxC-73-001-AMM and MT-Propeller E-2285:
 - a) Dismount propeller
 - b) Clean engine, propeller flange and bolts and nuts with solvent of gasoline. All surfaces must be dry and clean. Remove all surface defects.
 - c) Mount Propeller according MT-Propeller E-2285
- 3) Update ADxC-73-001-AMM to Issue 2.1
- 4) Make a log book entry and add note to aircraft CAW documentation that this Service bulletin has been incorporated.
