Update tow winch system installation	Doc-Nr: ADxC-73-SB-036 Issue: A Date: 27.06.2023 ChangeNr.: ADxC-DC-73-100
Service Bulletin

<p>Update tow winch system installation</p> <p>Optional update of the tow winch system</p> <ul style="list-style-type: none"> -Change of guillotine control handle surface to be knurled -Retrofit of a tail skid to the tow winch system at rear fuselage

- All BRM Aero B23 models and serial numbers with
- DC-025 (DC-003 with tow winch system),
- Or DC-076 (DC-049/058 with tow winch system)
- TCDS: EASA.A.642

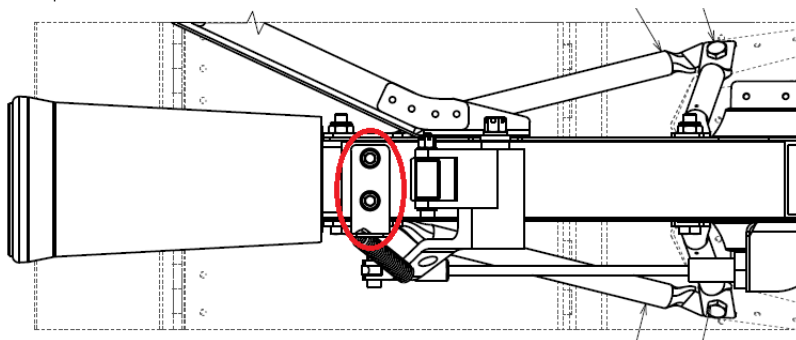
- 1) Tail skid installation
 - a) Dismount old bracket holding the return spring. See figure below, red ellipse: bracket to be replaced, seen from below.

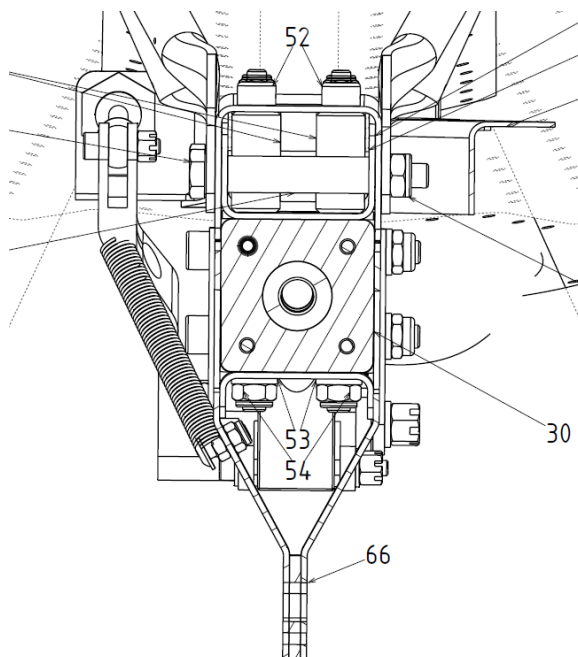
- b) See figure below, the fasteners [2 x bolts (52), 2 x washers (53), 2 x self-locking nuts (54)] can be reused. Now, their installation direction swapped versus the unchanged design.

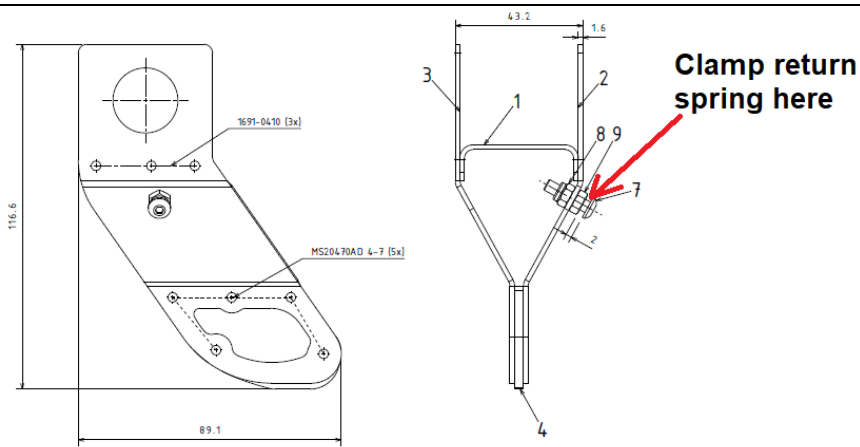
- c) Mount Tail skid.
 - d) Mount return spring. See figure below, it must be clamped between screw (7) and nut (9). Self-locking nut must be then tightened.

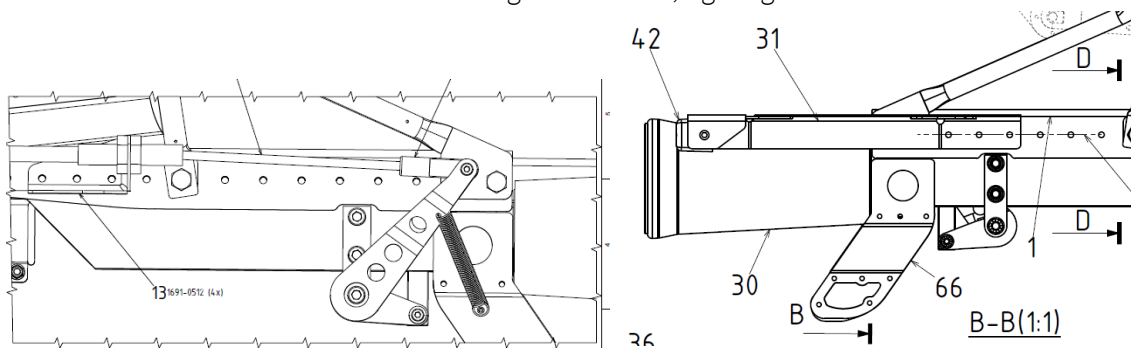
When assembled: left figure – LH side; right figure RH side
