Bristell B23	Doc-Nr: ADxC-73-SB-029 Issue: A Date: 09.02.2023 ChangeNr.: ADxC-73-DC-092
Service Bulletin

<p style="text-align: center;">Bristell B23</p> <p style="text-align: center;">Inspection and change of ballast attached to engine</p>

ATA 72 ENGINE – ballast attached at engine

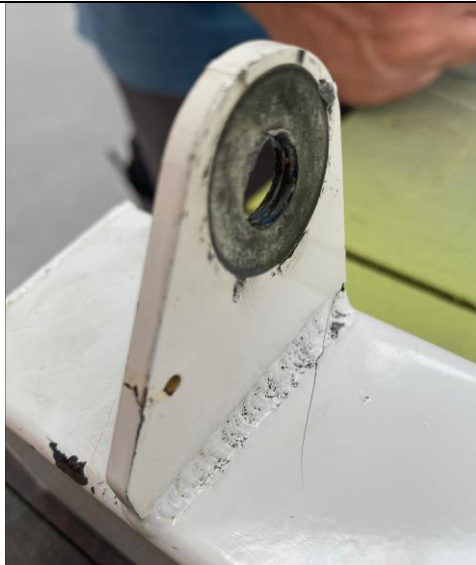
Insufficient or loss of attachment bolt torque can lead to excessive wear on attachment bolt shaft and cracks of attachment lugs due to resulting pounding vibration. This, if undetected over long period of time, could lead to partial loss of attachment.

- Visually inspect ballast for cracks: no cracks allowed, see Figure 2
- Visual inspect ballast attachment lug holes – no elongation or wear allowed. Nominal diameter of hole 10.0mm tolerance +0.015/-0.0

- Remove engine cowling
- Visually inspect ballast for cracks: no cracks allowed, see Figure 2
- IF cracks are found sent to BRM for repair/upgrade (immediate terminating action).
- IF ballast is free of cracks: Reinstall cowling.

Figure 2 Cracks found on ballast lug

- If cracks or hole wear is found sent to BRM for repair/upgrade (immediate terminating action).
- If ballast is free of cracks or hole wear reinstall ballast (mind correct orientation) using 71B200206N issue B Ballast bolt (2ea) and 71B200208N issue B washer (2ea)

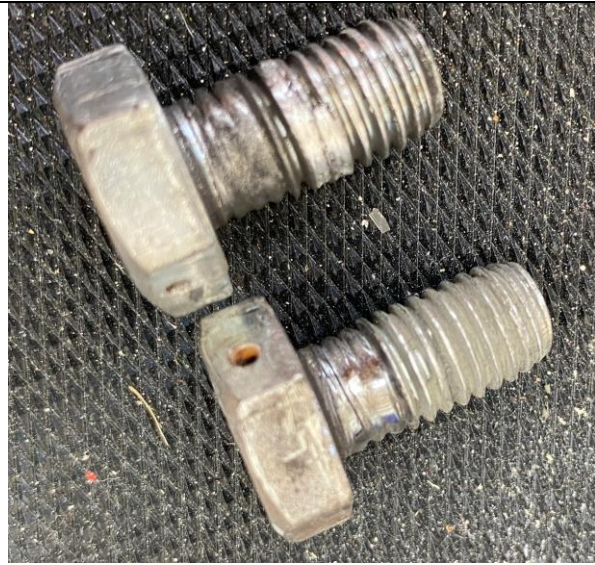
Figure 3 Bolts showing wear on thread

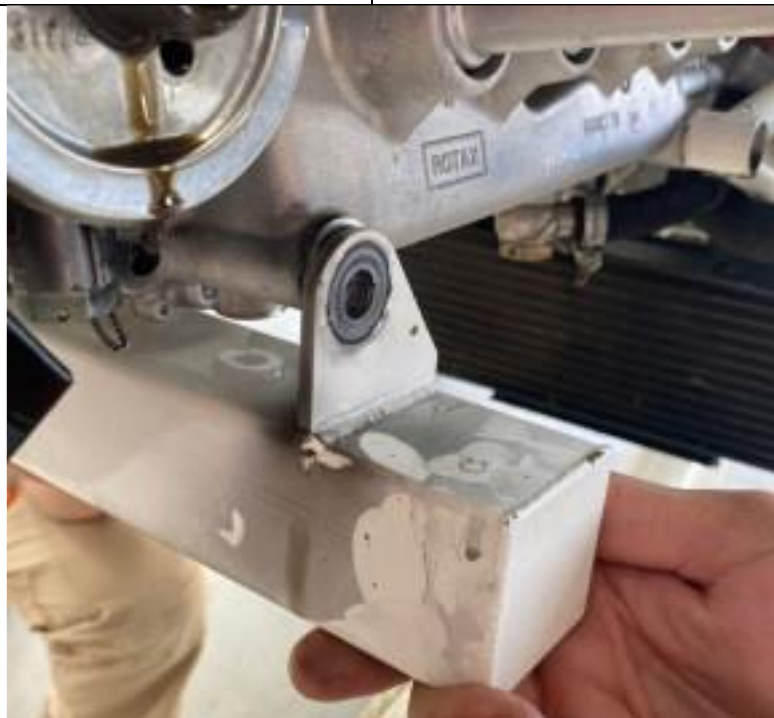
- Remove engine cowling
- Visually inspect the surface of the ballast for cracks occurrence in the area of attachment to the engine and/or signs of a loose connection indicated by the appearance of grey-black dust, see Figure 4 in Appendix.

Figure 4 Grey dust on ballast indicating wear on bolt/thread/attachment)

- Remove safety wire at ballast attachment bolts
- Remove bolts and ballast
- Discard bolts
- If grey dust was found: Visual inspect engine threaded hole: no thread damage is allowed. In case of thread damage contact BRM, installation of helicoil might be needed.
