Engine mass ballast	Doc-Nr: ADxC-73-SB-029 Issue: B Date: 17.10.2023 Change Nr.: ADxC-73-DC-105
Service Bulletin Bristell B23

<p>Engine mass ballast</p> <p>Removal or Change of ballast attached to engine</p> <p><i>Note: this service bulleting also replaces ADxC-73-SB-020.A</i></p>
--

ATA 72 ENGINE – ballast attached at engine

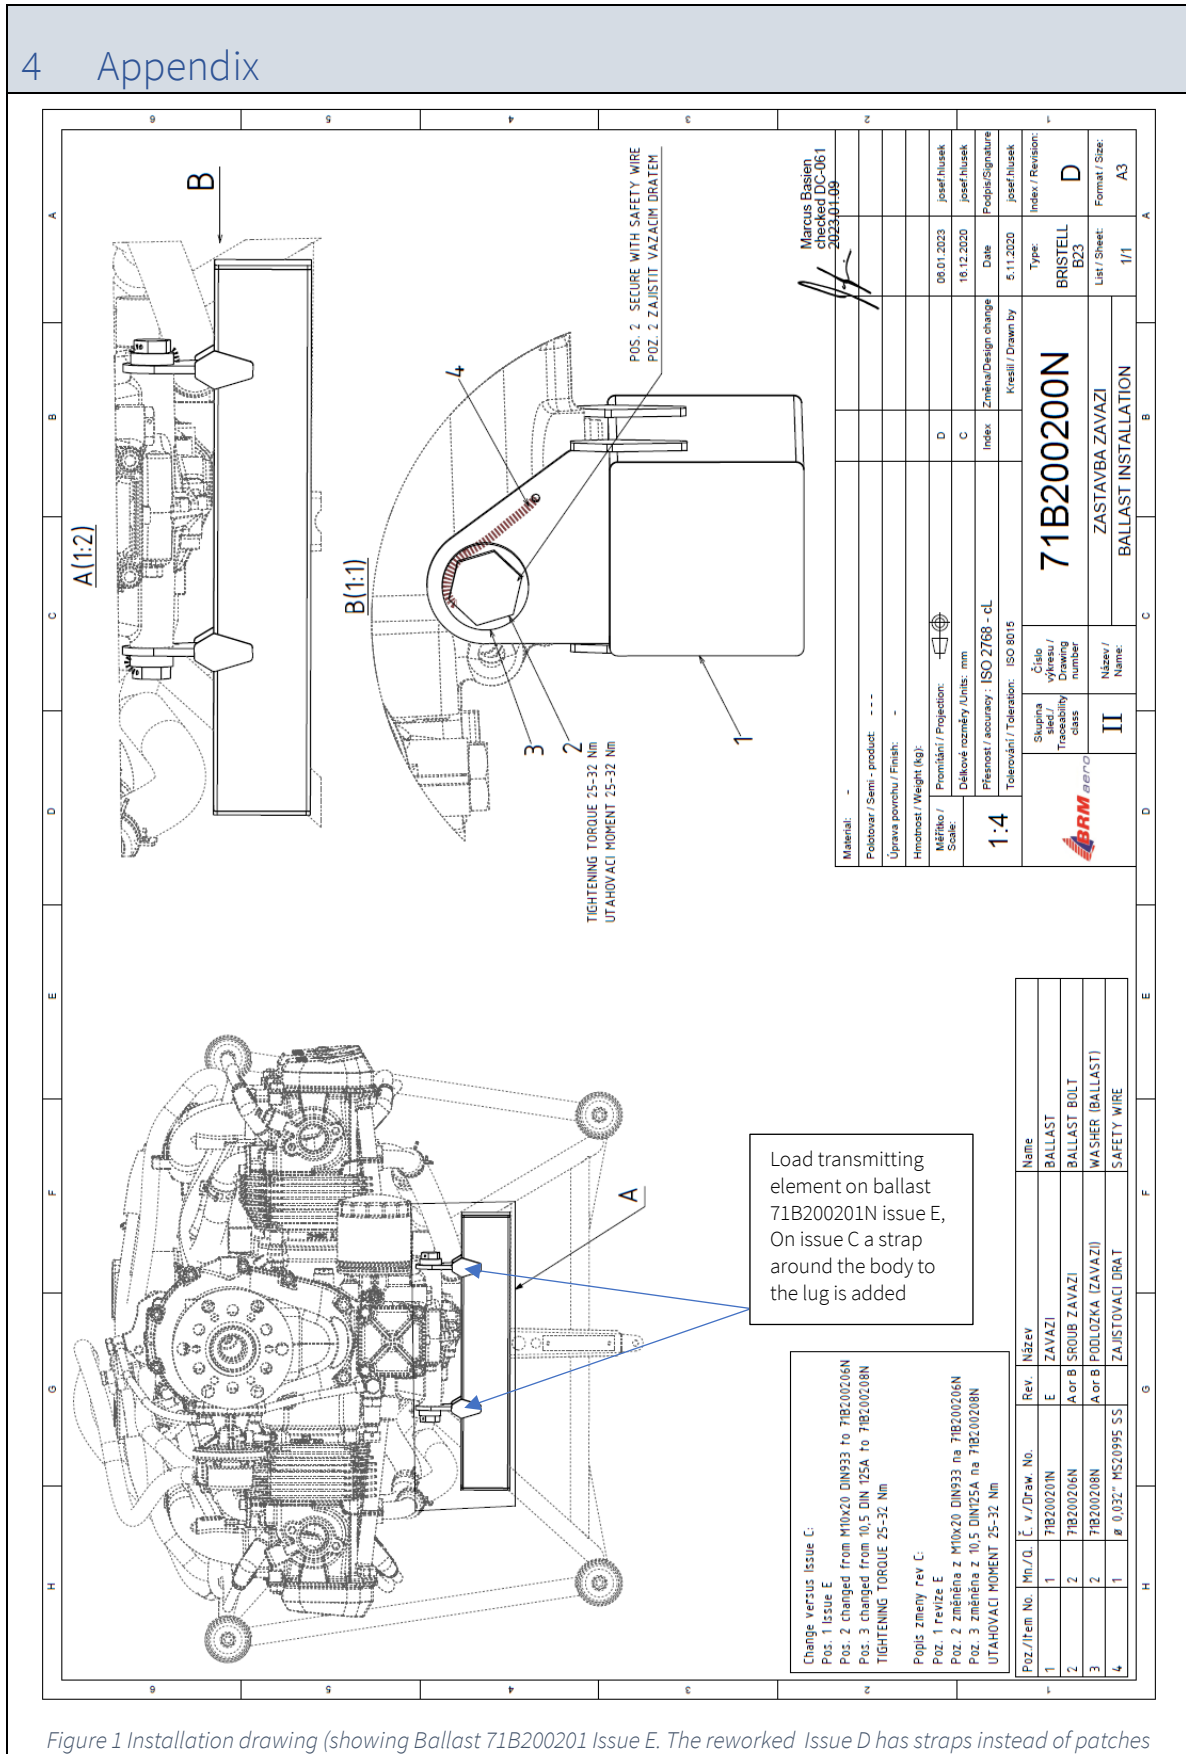
Figure 1 Installation drawing (showing Ballast 71B200201 Issue E. The reworked Issue D has straps instead of patches

- Remove engine cowling
- If ballast 71B200201N issue B or C is installed, remove ballast.
 - *Acceptable ballast issue D (reworked) or E (factory new) can be identified by presence of load transmitting elements between lug eye and body (ref. Figure 1), Issue D (reworked) has straps all around the ballast body, Issue E (factory new) has lug patches.*
 - *Not acceptable Issue B or C do not feature this (ref. Figure 4)*
- Reinstall cowling.

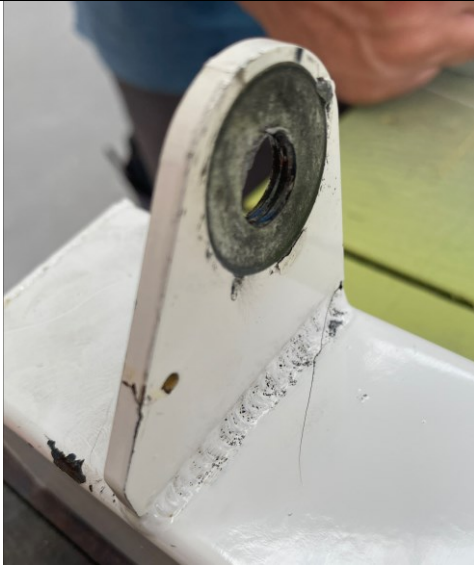
Insufficient or loss of attachment bolt torque can lead to excessive wear on attachment bolt shaft and cracks of attachment lugs due to resulting pounding vibration. This, if undetected over long period of time, could lead to partial or total loss of attachment. On one occurrence this did lead to inflight loss of the engine ballast mass. Refer to visualization in section 4.

Figure 2 Cracks found on ballast lug

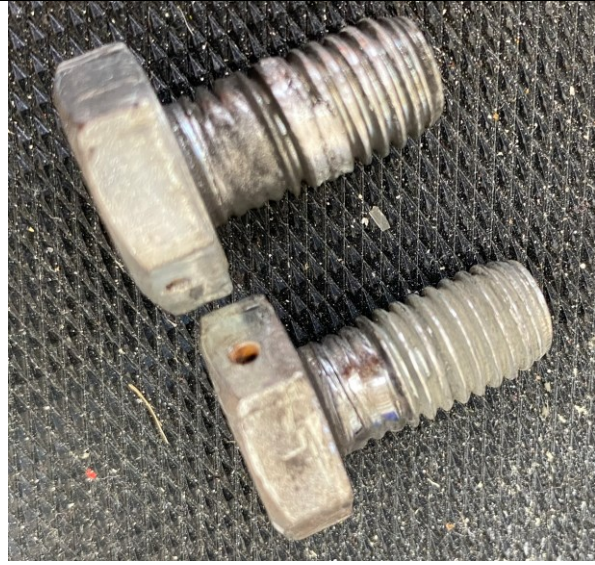
Figure 3 Bolts showing wear on thread

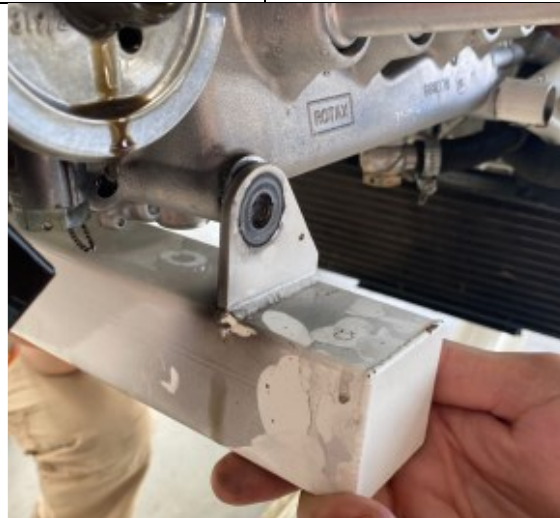
Figure 4 Grey dust on ballast indicating wear on bolt/thread/attachment); ballast 71B200201N issue C shown

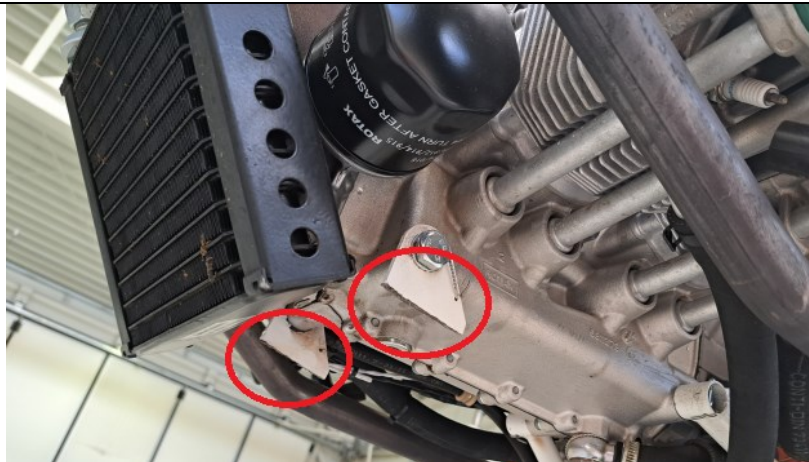
Figure 5 Remaining lugs after loss of ballast
