Elevator and tab deflections, gurney flap	Doc-Nr: ADxC-73-SB-039 Issue: A Date: 23.11.2023 Change Nr.: DC-074
Service Bulletin Bristell B23

Elevator and tab deflections, gurney flap
SERVICE BULLETIN BRISTELL B23

ATA 27 FLIGHT CONTROLS

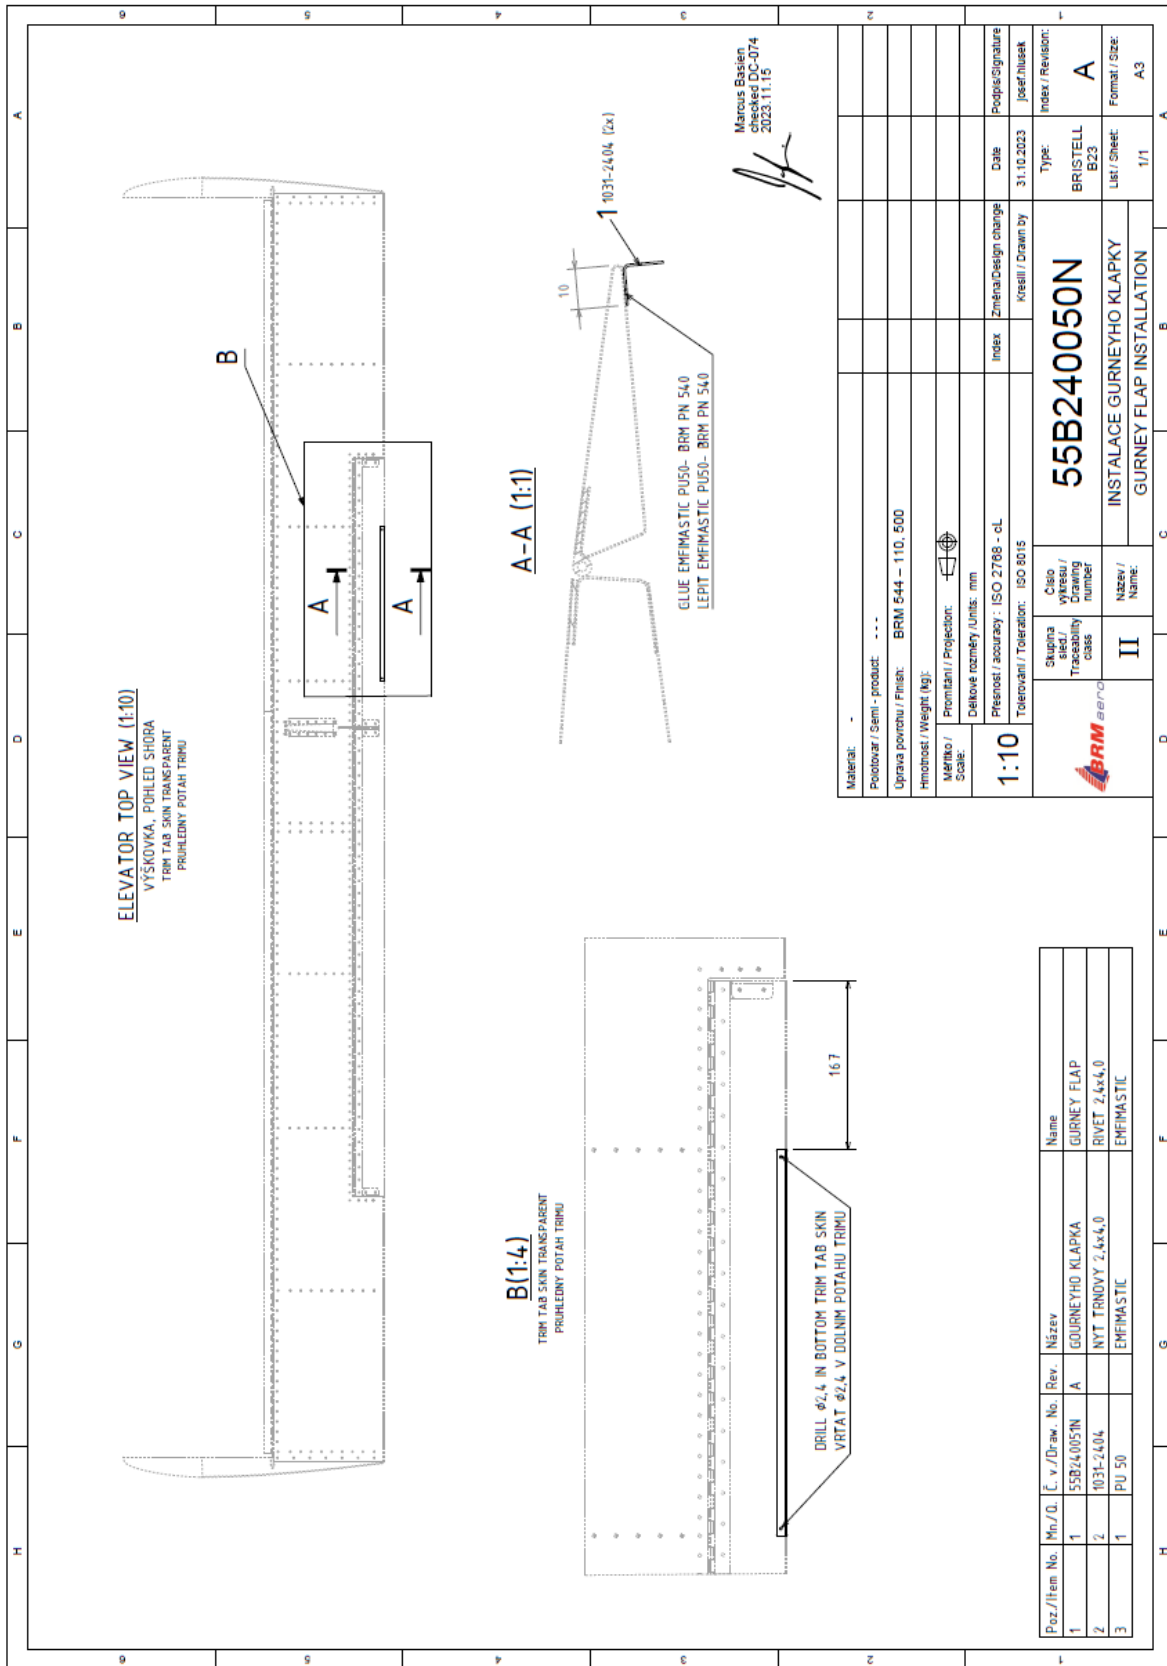
55B240050N Issue A Gurney flap installation drawing

- Gurney flap:
 - o The optional gurney flap improves the low speed trim point on cost of high speed trim point.
 - o Due to its detail location it has more influence on the (critical) power-off trim range than on the power-on trim.

- o The gurney flap mounts to the rearmost end of the tab and therefore is relevant with respect to tab and elevator static moment. The result of the addition must be checked against limits according ADxC-73-AMM-001 section 51-60. Update airplane life cycle documents accordingly.

- b) If permissible install gurney flap per drawing 55B240050N Issue A
 - c) After complete installation, perform deflection measuring of elevator and trim tab. See ADxC-73-AMM-001 Section 20-50-01 and 20-60-01.
