Electric System (IBBS / CAS Message / Fillerneck bonding)
SERVICE BULLETIN BRISTELL B23

Electric System (IBBS / CAS Message / Fillerneck bonding)	Doc-Nr: ADxC-73-SB-037 Issue: A Date: 23.11.2023 Change Nr.: DC-104
Service Bulletin Bristell B23

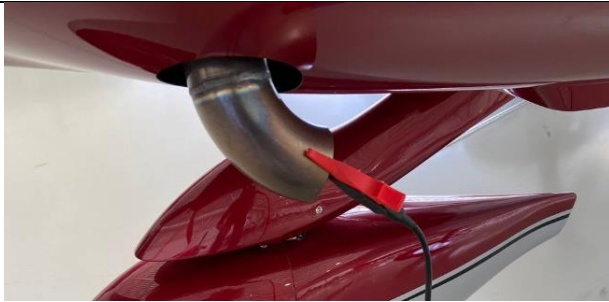
The filler neck original part as delivered features a anodised surface which for the practical purposes of discharging is isolating. The (improved) rivet connection drills out some material providing a clean, not anodised surface, the (new) rivet bridges from the filler neck to the skin. In production this clean surface inconsistently is wetted with sealing compound preventing good conductivity.

- On the filler use a sharp test head poking with force through the actual surface OR use a tube, simulating the fuel-filler “pistol” and rotate with moderate force against the inner flange edge. Do not measure on the rivets or skin or filler cap.

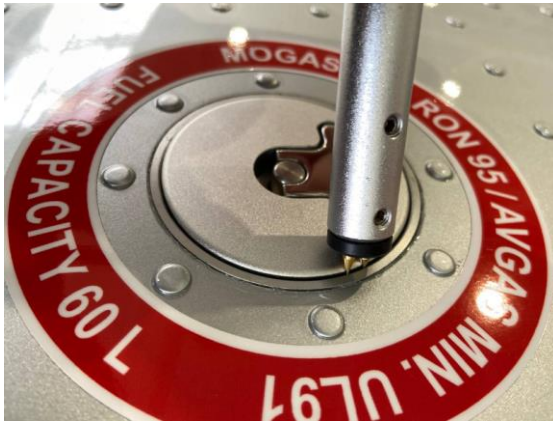
- The acceptable resistivity is $R < 50\text{m}\Omega$. The measured resistivity of the wiring alone must be accounted for (tara). Hence, measurement point to point max 0.05Ω + measurement wiring.
- Test must be performed for each tank.

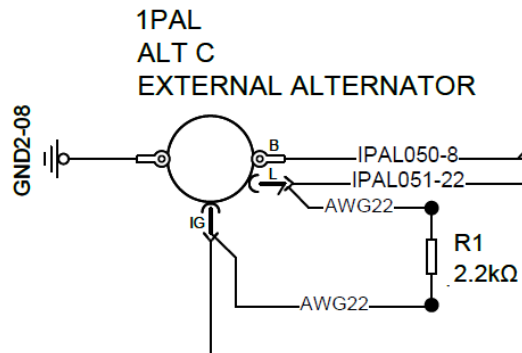
- VII. ALT 2 and ALT C R1 Resistor exchange (optional):
 - The resistor is attached directly to the alternator. Vibrations can cause this resistor connection to brake. The resistor can be replaced with a sturdier resistor and can be installed at a location closer to the firewall, where less vibrations are present.

- Identify the existing R1 resistor at the ALT 2 or ALT C alternator, see example for ALT C.

- Install the new resistor according to drawing 34B220000N (Rotax 912), 34B520000N (Rotax 915iS), 34B920000N (Rotax 915-G500), 34B620000N (Rotax 912-G500). Place the R1 resistor further away of the alternator and closer to the firewall of the aircraft.
