BRMAERO		BULLETIN TITLE:		ROTAX 912 IS ENC ATTACHMENT	SINE
	_	Wings with heart	CLAS	SIFICATION:	SAFETY DIRECTIV	/E/ALERT
Letecká	255	Tel.:+420 773 984 338	BULL	ETIN <u>NU</u> MBER	R: ALL-SA-5-0-0-ALL	-0001-2024
686 04 k	Kunovice	info@brmaero.com	Date of	issue: 08.02.20	24 Revision no.: 1st issue	Page: 1
Czech R	lepublic	www.brmaero.com	Date of	effect: 08.02.20	Date of rev.: -	Pages: 17
0 RI	ECORD O	F	Rev.No.	Affected pages	Reason	Date
R	EVISIONS	5				
1 GI IN	ENERAL IFORMAT	ION		L

Engine mounts for Rotax 912 iS engine

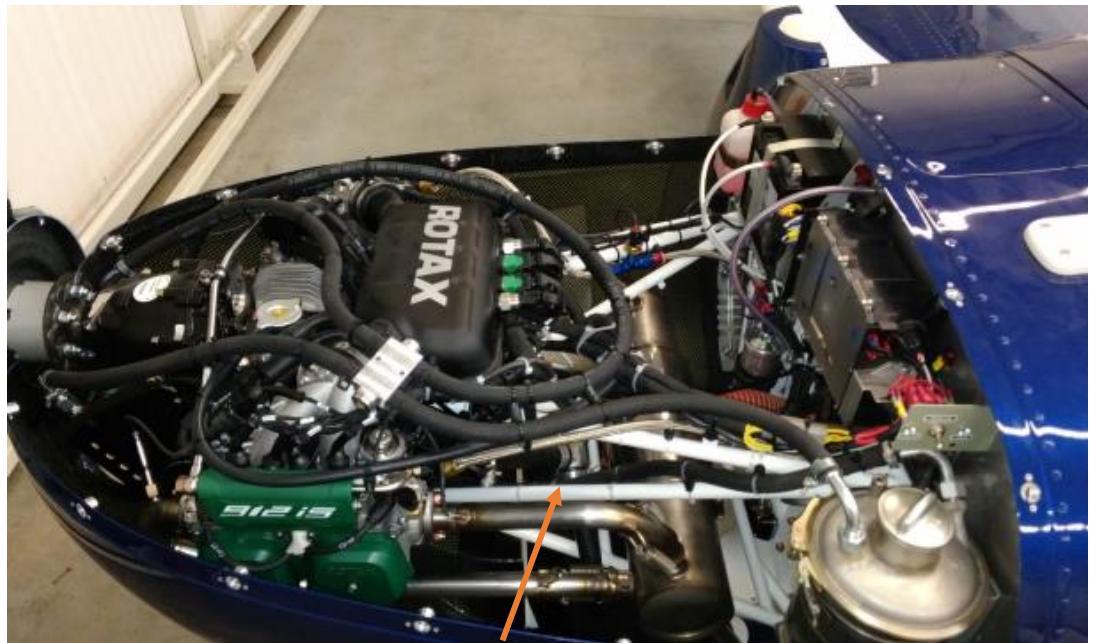
1.1	Affected a	aircraft				
1.1.1	Туре:		BRISTE	ELL UL/LSA		
			(UL=Ult	tra-Light Aircra	ft, LSA=Light Sport Aircra	ft)
1.1.2	Model:		All mod	dels equipped	with Rotax 912 iS engin	e
			and the		piece engine mount	
			(ऽस्ट मार् It does	not apply to ai	craft with a two-piece end	ine bed with a
			ring (se	e Figure 2).		
			It also c as desc	loes not apply ribed in this bu	to aircraft that have alread	dy been modified

Figure 1 Original (one-piece) engine mount for Rotax 912 iS – affected by this bulletin

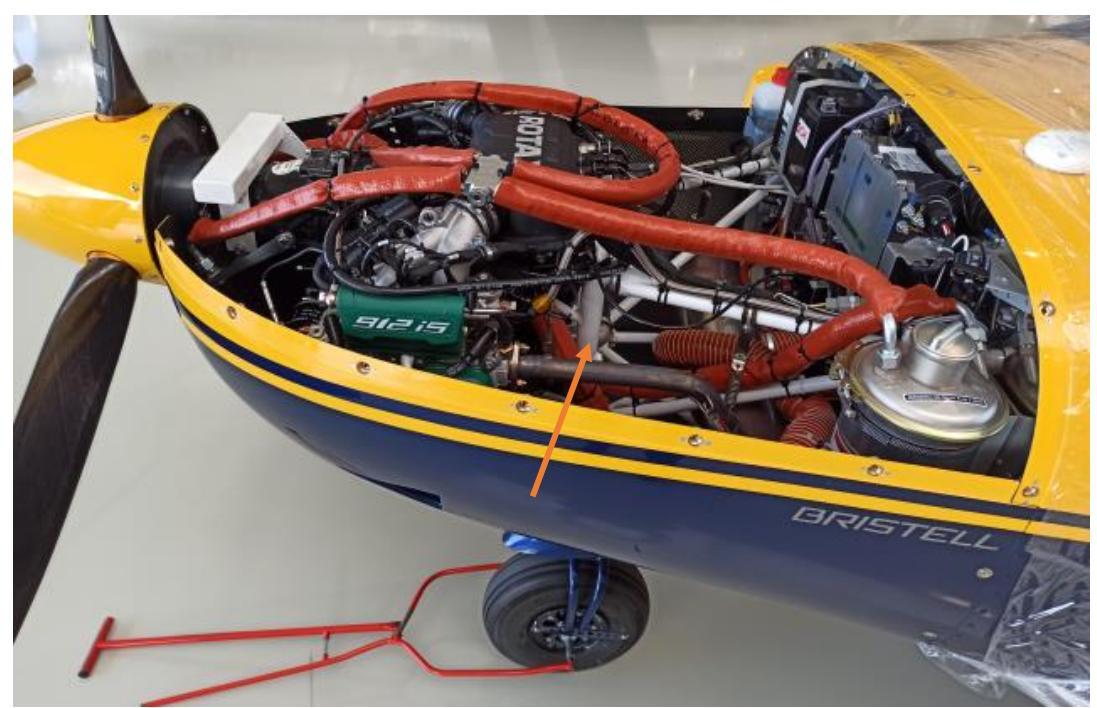
Figure 2 Two-piece engine mount with ring – NOT affected by the bulletin

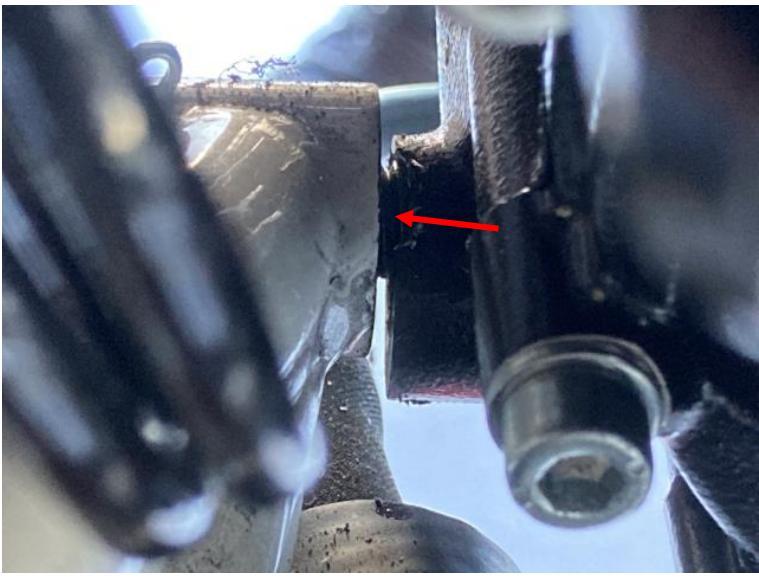
To check that the lower left hand Allen screw securing the Rotax 912 iS to the engine mount is not sheared off (see Figure 3)

- Allen screw head seated up to the cotter pin (originally there was a gap between the two).
- Abrasion of the engine mount paint in the area around the screw head.
- Possible damage (e.g. to the engine mount paint) in the area of the water pump (including coolant leaks from the water pump) due to increased vibration
- Change increase of engine vibration when running

If there is any doubt as to whether or not the screw is sheared off, the cotter pin must be removed and the screw tightened with an Allen key. If it is turning, the screw has been sheared off.

Figure 3 Loose Screw connection (lower left Screw) between the engine mount and the engine case.

WARNING: If the screw is found to be sheared, DO NOT CONTINUE OPERATION until the fault is rectified !

If the screw has not sheared off, operation may continue until the next periodic inspection, at which time the screws must be replaced with new ones (thread secured with Loctite 243), including installation of Nord-lock washers and new cotter pins.

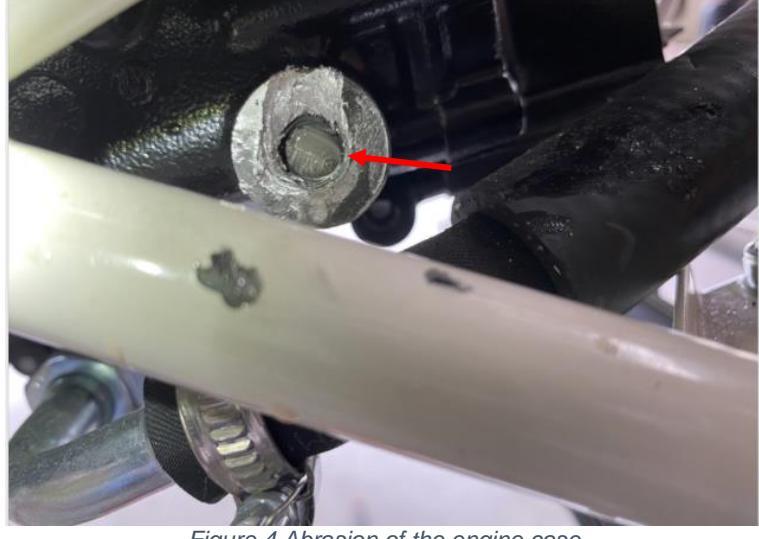
Figure 4 Abrasion of the engine case with a Screw broken off inside

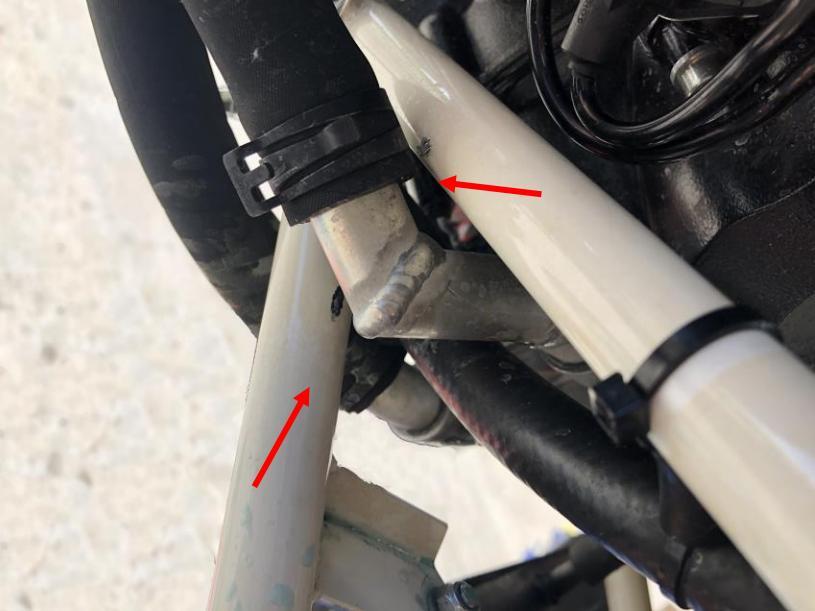
Figure 5 Damage to the engine mount paint from the water pump pipe due to higher engine vibrations (after cutting off the Screw)

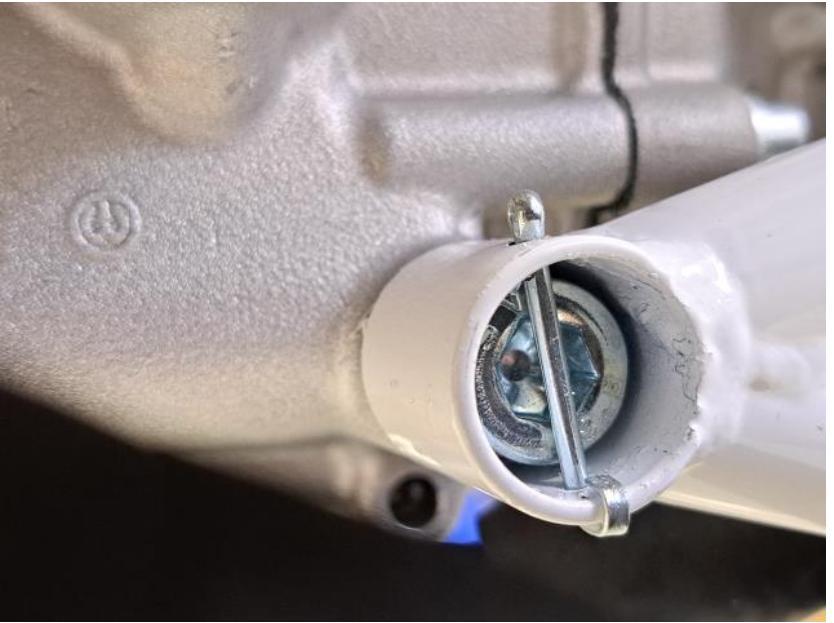
Figure 6 Screw head secured with a cotter pin
