Elevator and tab deflections, gurney flap	Doc-Nr: ADxC-73-SB-039 Issue: A Date: 23.11.2023 Change Nr.: DC-074
Service Bulletin Bristell B23

Elevator and tab deflections, gurney flap
SERVICE BULLETIN BRISTELL B23

ATA 27 FLIGHT CONTROLS

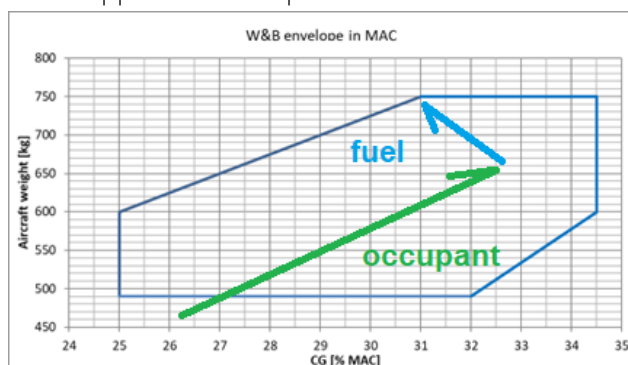
- it is not necessary to reach trim travel stop in the tests
- approach the limits with care
- perform test in calm weather condition
- perform test at practical FWG CG (full fuel, no luggage) and close to MTOW 750kg, do not exceed the approved envelope.

- 1) Update airplane maintenance and flight manual to latest applicable edition.
- 2) If installation of gurney flap is wanted
 - a) Check if control surface weight and balance (mass and static moment about hinge line) has enough reserve to add the gurney flap. The gurney adds 12g of mass and 0.0032kg/m of static moment. If simultaneous repair or top surface coat renewal is done perform elevator/tab weight and balance according ADxC-73-AMM-001 Section 51-60.
