BRM Aero - replacement of oil cooler DC-045	Doc-Nr: ADxC-73-SB-015 Issue: A Date: 26.08.2022 ChangeNr.: ADxC-DC-73-045
Service Bulletin

### BRM Aero - replacement of oil cooler DC-045

Replacement of original type design oil cooler by larger oil cooler to increase cooling capacity.  
Subsequent modification of cowling to fit to the larger oil cooler.

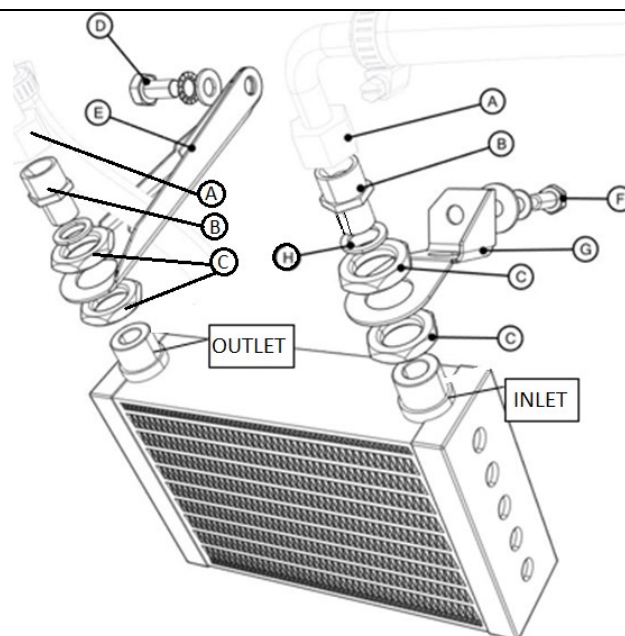
- 1) Remove the upper and the lower engine cowlings (acc. to ADxC-73-001-AMM)
- 2) If necessary, let the engine (and oil temperature) cool to ambient temperature.

- 3) Unscrew the inlet and outlet hoses (**A** ; wrench size 19mm and 22mm)  
*Note: A small amount of oil may leak from the hoses, use a container to capture.*

- 4) Remove both the inlet and outlet adapters (ADAPTER M18x1.5/M14x1.5 **B** ; PN 000780, wrench Size 19mm). Clean and check for reinstallation.
- 5) Remove all 4 nuts fixing the radiator in the brackets (**C** ; a very flat wrench size 30mm is needed for the bottom nuts). Remove the radiator (watch out for oil in the radiator).  
*Note: A protective hose falls out of the space behind the radiator (between radiator and oil pump). Keep it for the re-installation.*

- 6) Unscrew the bolt holding the left (inlet) bracket (**F** ; wrench size 13mm).  
*Note: Cut the safety lock wire on the bolt before this step.*
- 7) Remove the left (**G** ; inlet) bracket.

- 8) Install the new left bracket 71B230051N and gently screw the bolt in (**G** ; without tightening).
- 9) Release the hose clamp of the fuel pump drain hose routed through the right bracket (on the fuel pump side; wrench size 7).

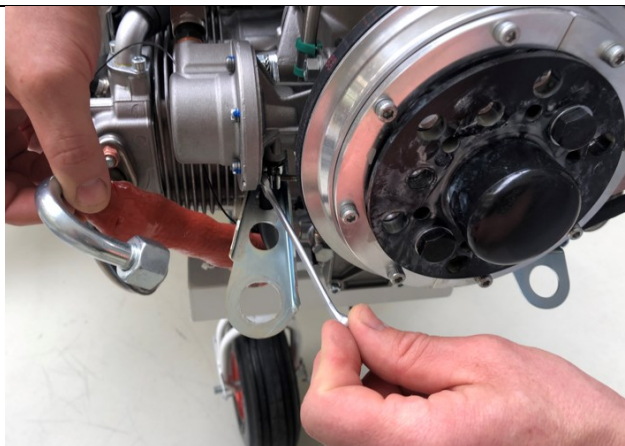
- 10) Unscrew the bolt of the right bracket M10x20 (D ; wrench size 16mm or 17mm).

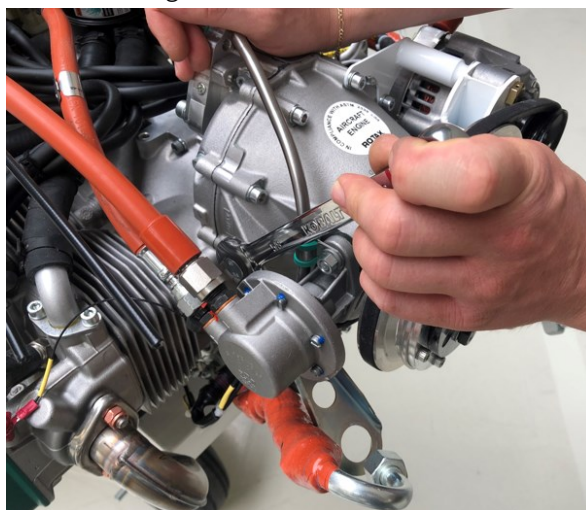
- 11) Disconnect the fuel pump drain hose on the fuel pump side and remove the right (outlet) bracket (E)  
*Note: this is a good moment to check the drain hose being unobstructed, by simply blowing into it.*
- 12) Position the new right bracket 71B230052N (E), route the fuel pump drain hose through the second largest opening (see below) and re-connect the drain hose to the fuel pump again and secure with the hose clamp.

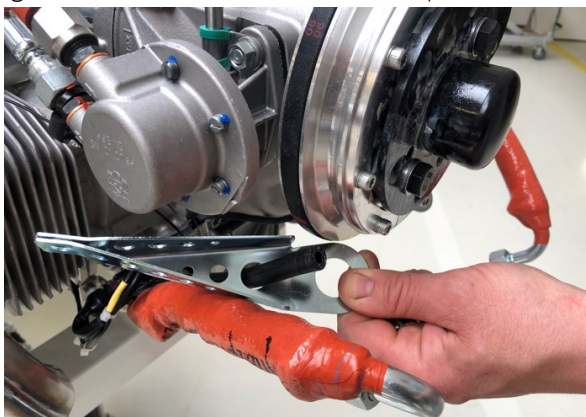
- 13) Bolt the right bracket using the bolt and washer removed in step 10)

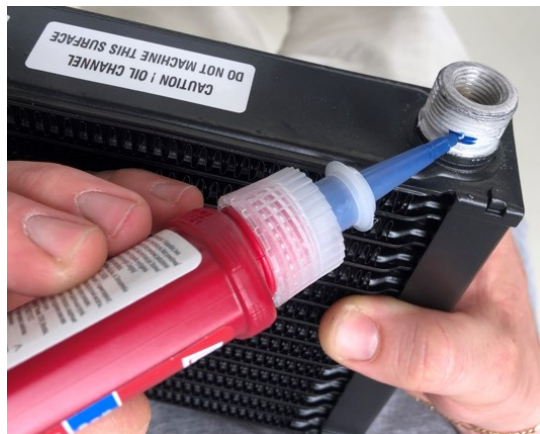
- 14) Use the replacement oil radiator P/N 886107, apply Loctite 243 to the inlet/outlet thread and screw the lower nut on both the radiator inlet and outlet threads.

*Note: before any action with the oil cooler is performed inspect the cooler for transport damage and check presence of caps preventing contamination of the cooler. If no caps are present, or in case of doubt, flush the oil cooler thoroughly. After removing the caps extreme care must be exercised to avoid entry of any objects.*

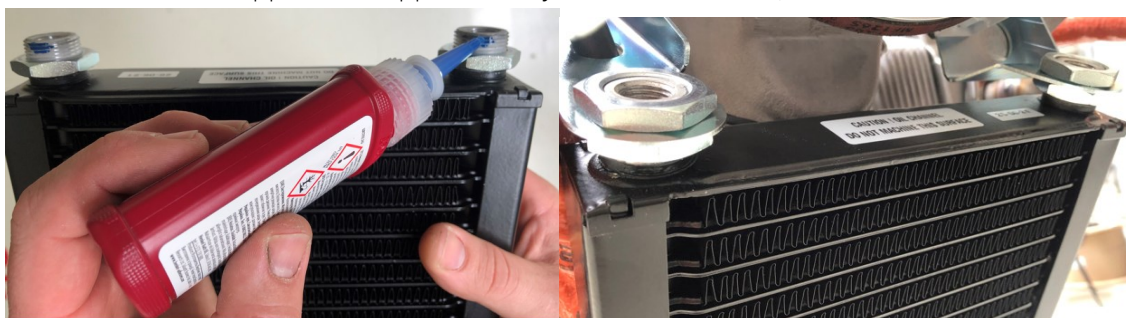
- 15) Apply Loctite 243 to the thread again and mount the oil radiator on the brackets so that the upper nut is approximately flush with the inlet/outlet tube ends.

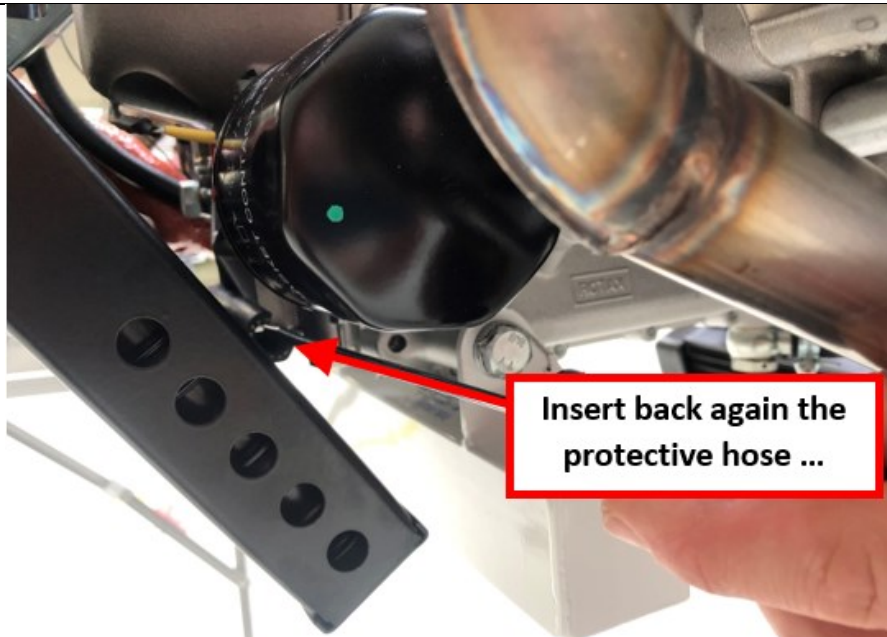
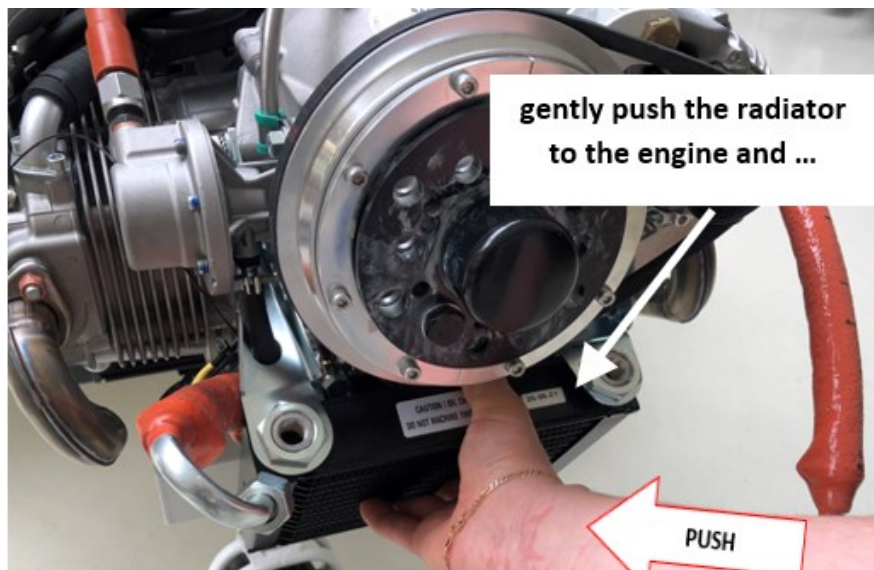
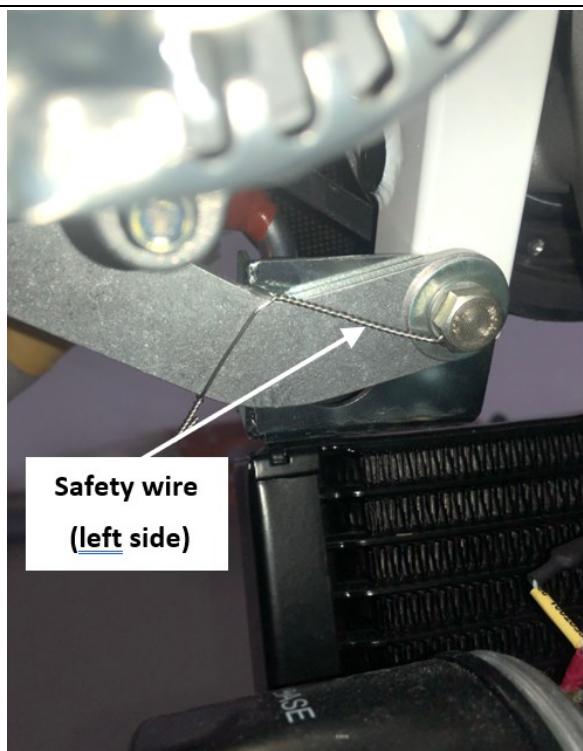
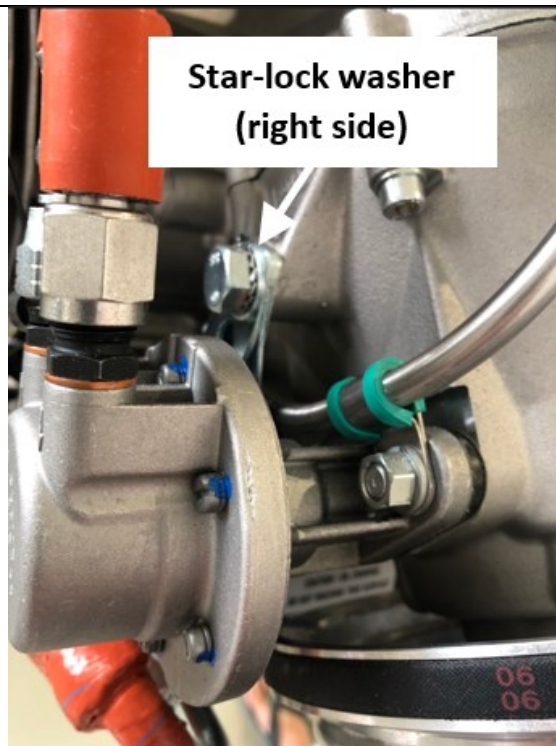
- 16) Tighten the lower nuts against the bracket (torque moment: M8 20-22Nm M10 40-42Nm)
- 17) Insert back again the protective hose (see the Note in step 5) between the radiator and the oil pump, gently push the radiator to the engine and tighten the bolts fixing the brackets to the engine (left/right). Secure with safety wire on the LHS and with new installed star-lock washer on the RHS (see pictures below)

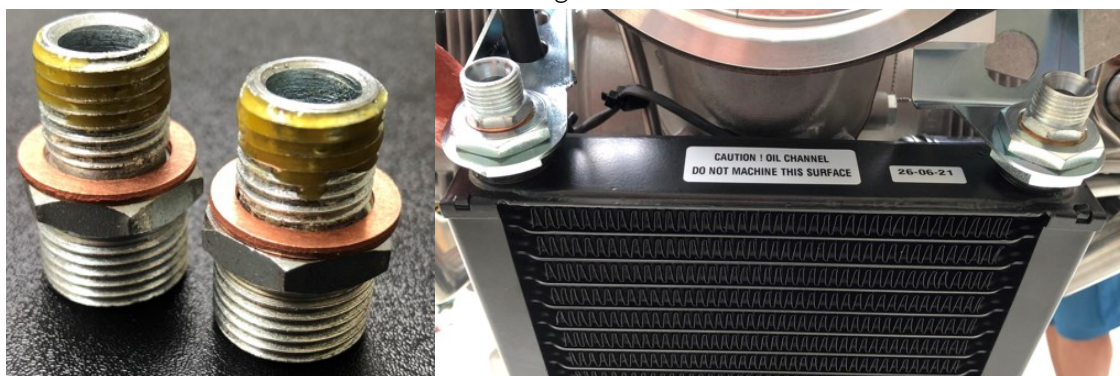
- 18) Install a new washer (H ; copper washer 20x14x1,5) on the reduction (B)
- 19) Apply sealing Loctite 577 to both reduction nuts (they must be cleaned oil free), screw the reductions in the radiator and tighten with a wrench size 19.

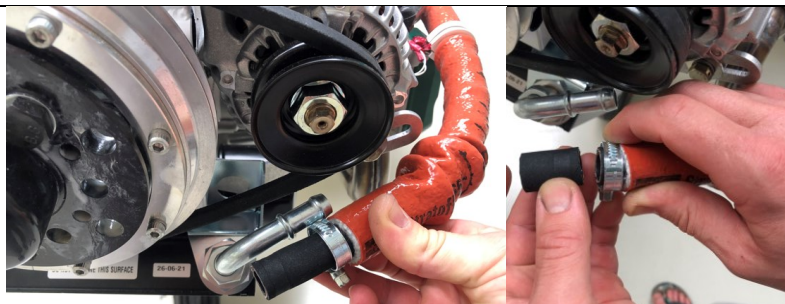
- 20) Remove the tape on the end of the protective sleeve on both inlet and outlet hose, slide the fire protection sleeve back to get to the hose clamp and cut and remove safety lock wire.
- 21) Release the hose clamp (wrench size 7) and pull the bend steel fittings (left 180°, right 90°) out of the hose.
- 22) To define the correct hose length, mount the steel fitting on the radiator inlet/outlet, route the hose parallel to it and cut to an appropriate length. Usually about 20 mm of hose need to be cut. Repeat for the fire sleeve.

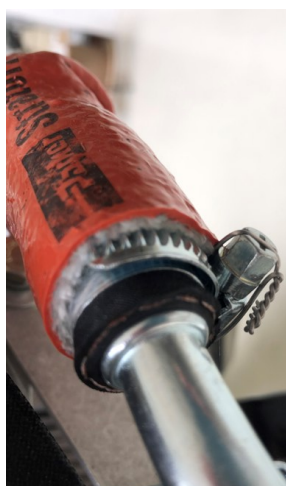
- 23) Slide the hose onto the steel fitting, tighten with the hose clamp and secure with a safety lock wire.

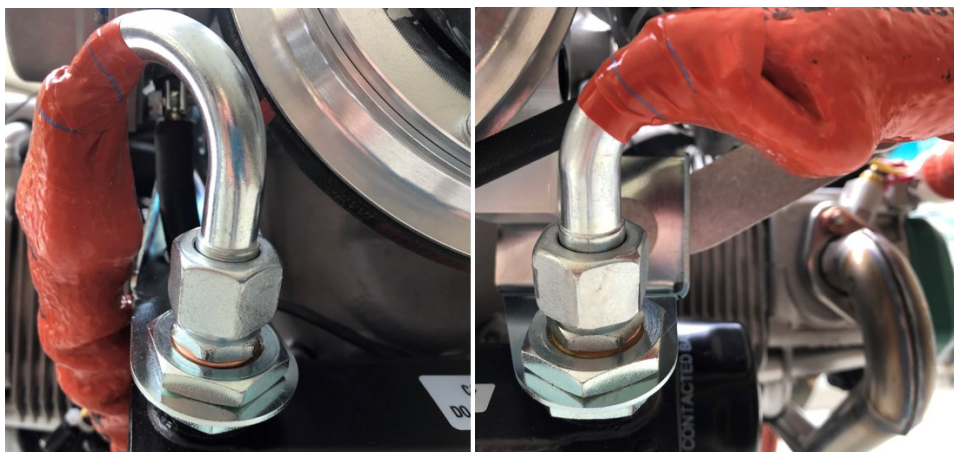
- 24) Pull the protective sleeve over the clamp and wrap with termination protective tape.  
25) Tighten the fitting on the radiator with a wrench size 19 and 22 (Torque moment)  
26) Final installation:

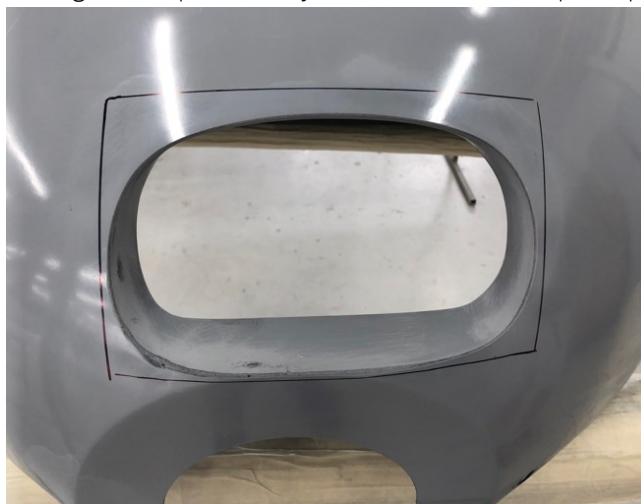
- 1) Cut-out the inlet opening in the engine cowling so that the replacement inlet part fits into the cowling. This is preliminary cut and does not require specific tolerances.

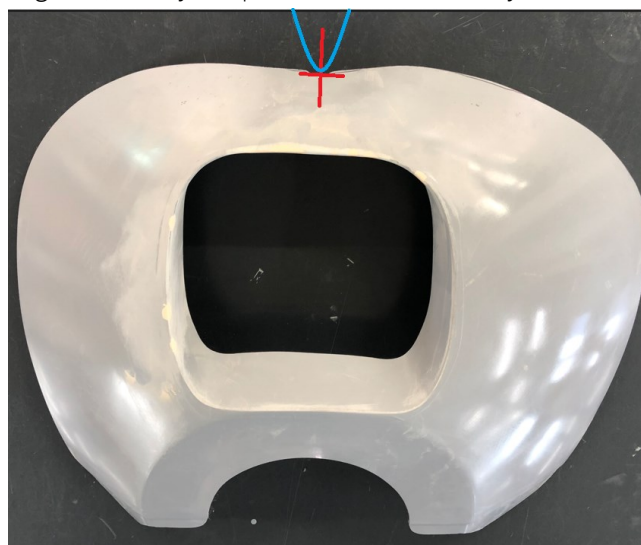
- 2) Position the replacement inlet part to the cowling so that the NACA inlets (shown blue) are aligned (modify the pre-cut-out if necessary)

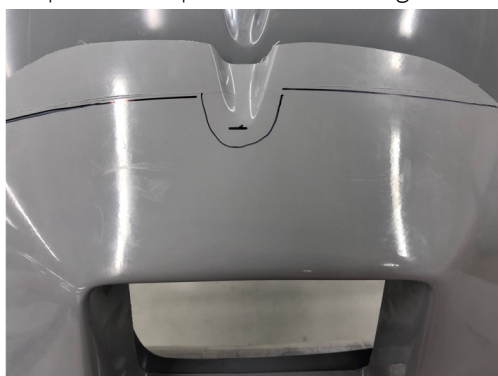
- 4) Position the replacement inlet part to the cowling and accurately outline the shape on the engine cowling.
- 5) Mark the outline of the replacement part on the cowling:

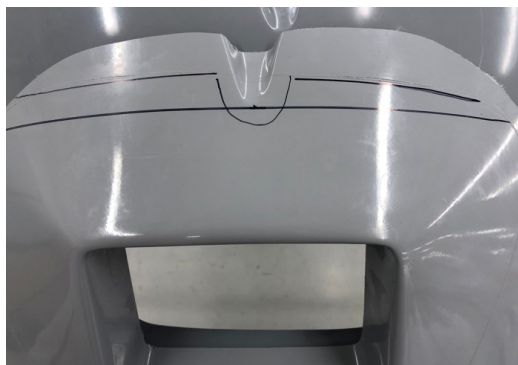
- 6) Cut the lower section of the replacement part (side of the NACA-incision, shown upside down in the pictures) about two inches from the edge and mark again on the cowling:

*Note: the NACA inlet incision on the replacement inlet part serves only for correct alignment of the replacement inlet part with the engine cowling. In this step the NACA incision on the replacement inlet part needs to be removed! Do not cut the NACA inlet on the cowling!*

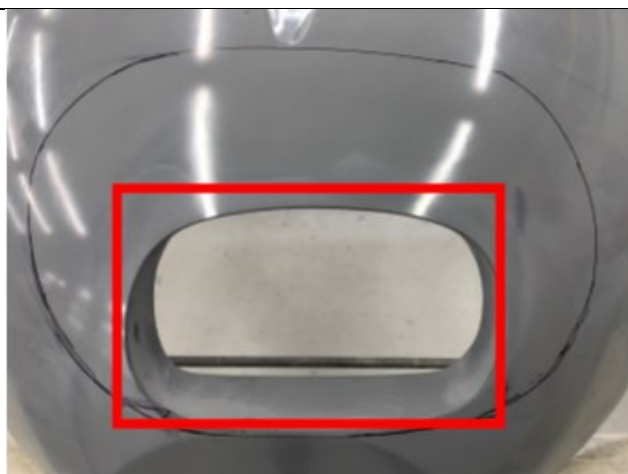
- 7) Following the outlined shape make an accurate cut-out in the engine cowling. (in red marked the pre-cut-out area that is already removed)

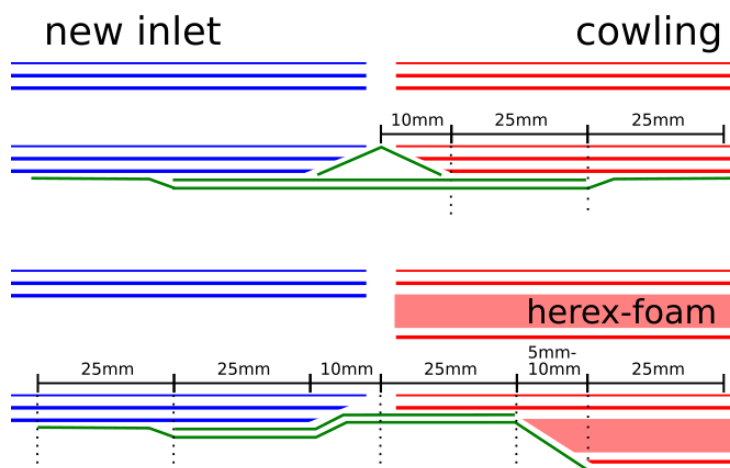
- 8) Remove the peel ply fabric from inside of the replacement inlet part.
- 9) From the outside of the cowling, apply the position the inlet part into the cowling cut-out and fasten it thoroughly from the outside with tape. Inside the cowling, grind the composite parts around the cut-out as shown in the schematics below (depending if herex-foam is part of the lay-up or not)

- 10) Laminate the joint with two layers of carbon fabric (CARBON GG 200 P PLAIN (45°) 200g/m<sup>2</sup>; shown green) with following layup positioned +45° locally to the cut line:
